Apollo CSM Power Generation System Design Considerations, Failure Modes and Lessons Learned

CSM EPS Lessons

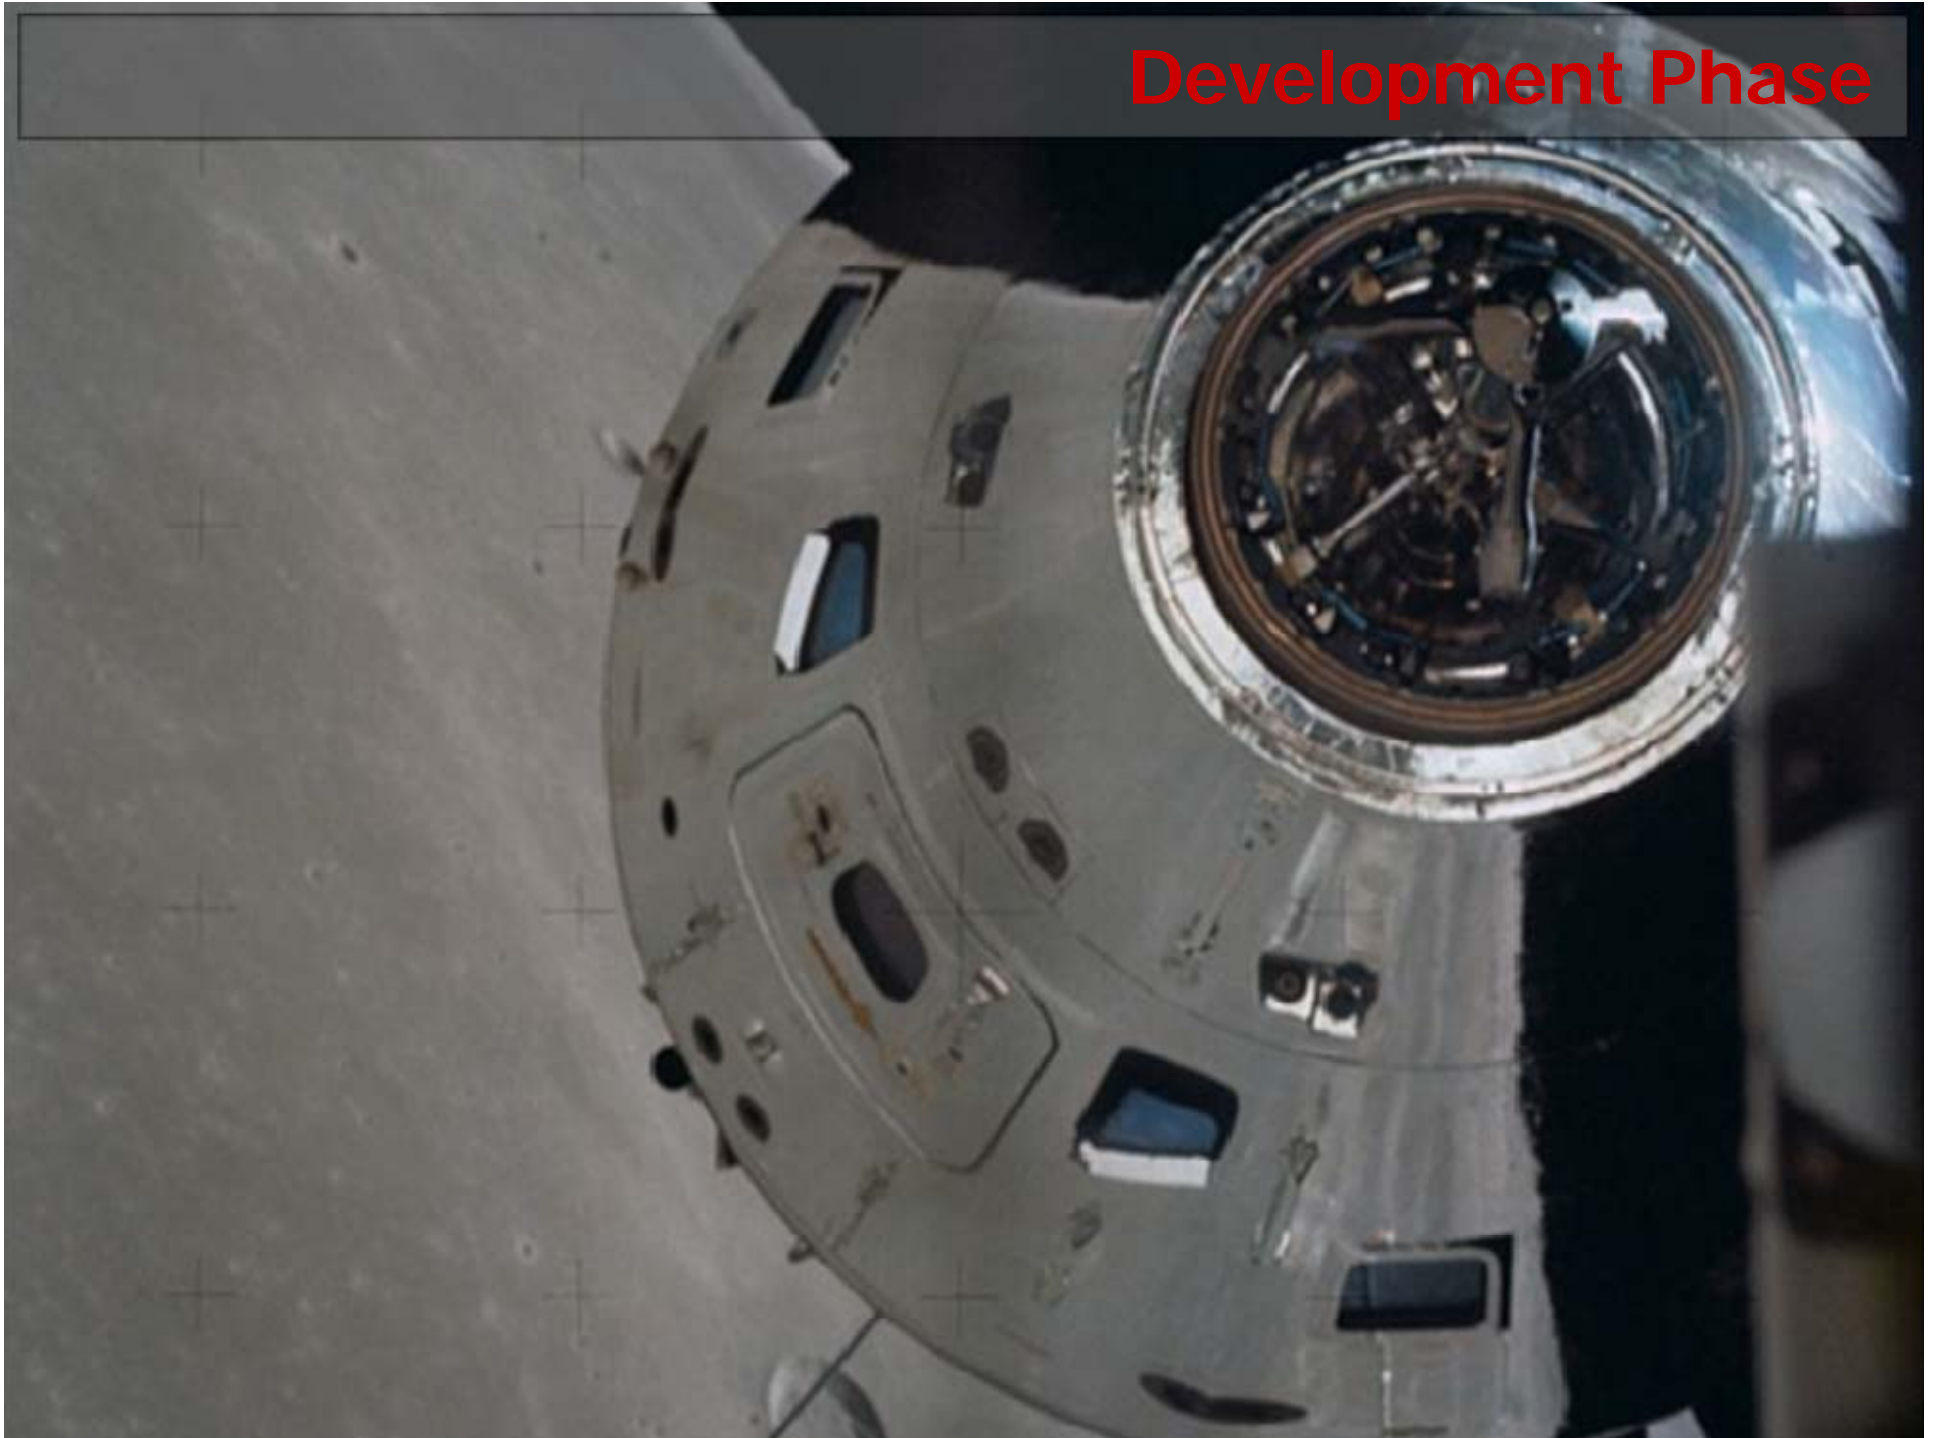
Development Phase

- ❑ Concept for 1.5 (kW) FC came from the Gemini program
 - Gemini program utilized Ion Exchange Membrane (IEM) FC

FUEL CELLS - ION EXCHANGE MEMBRANE

SIX PARALLELED STACKS @
.35 KW EACH

FUEL CELLS - BACON

TWO PARALLELED
MODULES @ 1.05 KW EACH

CHEMICAL DYNAMIC - TURBINE

TWO 2.1 KW SYSTEMS,
ONE ACTIVE-ONE STANDBY

CRYHOCYCLE

TWO 2.1 KW SYSTEMS, ONE ACTIVE-
ONE STANDBY

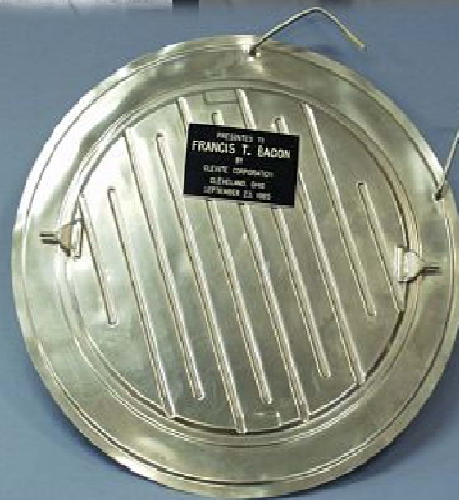
Electrolyte Seal

- ❑ Leakage of electrolyte at the periphery of the unit cell

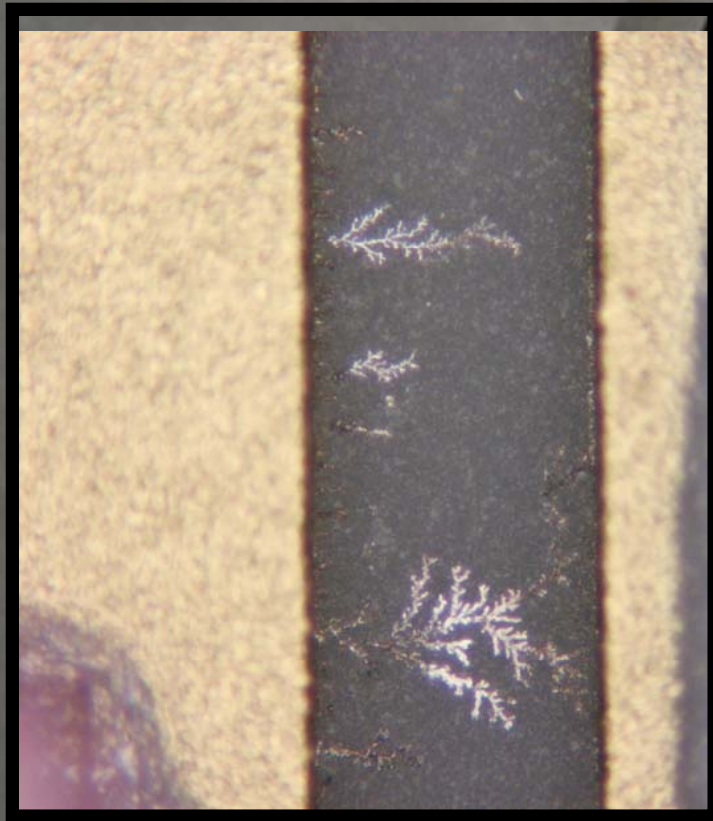
Dendrite Formation

❑ FC shorted out internally during shutdown

Silver dendrite experiment from Goddard Space Flight Center

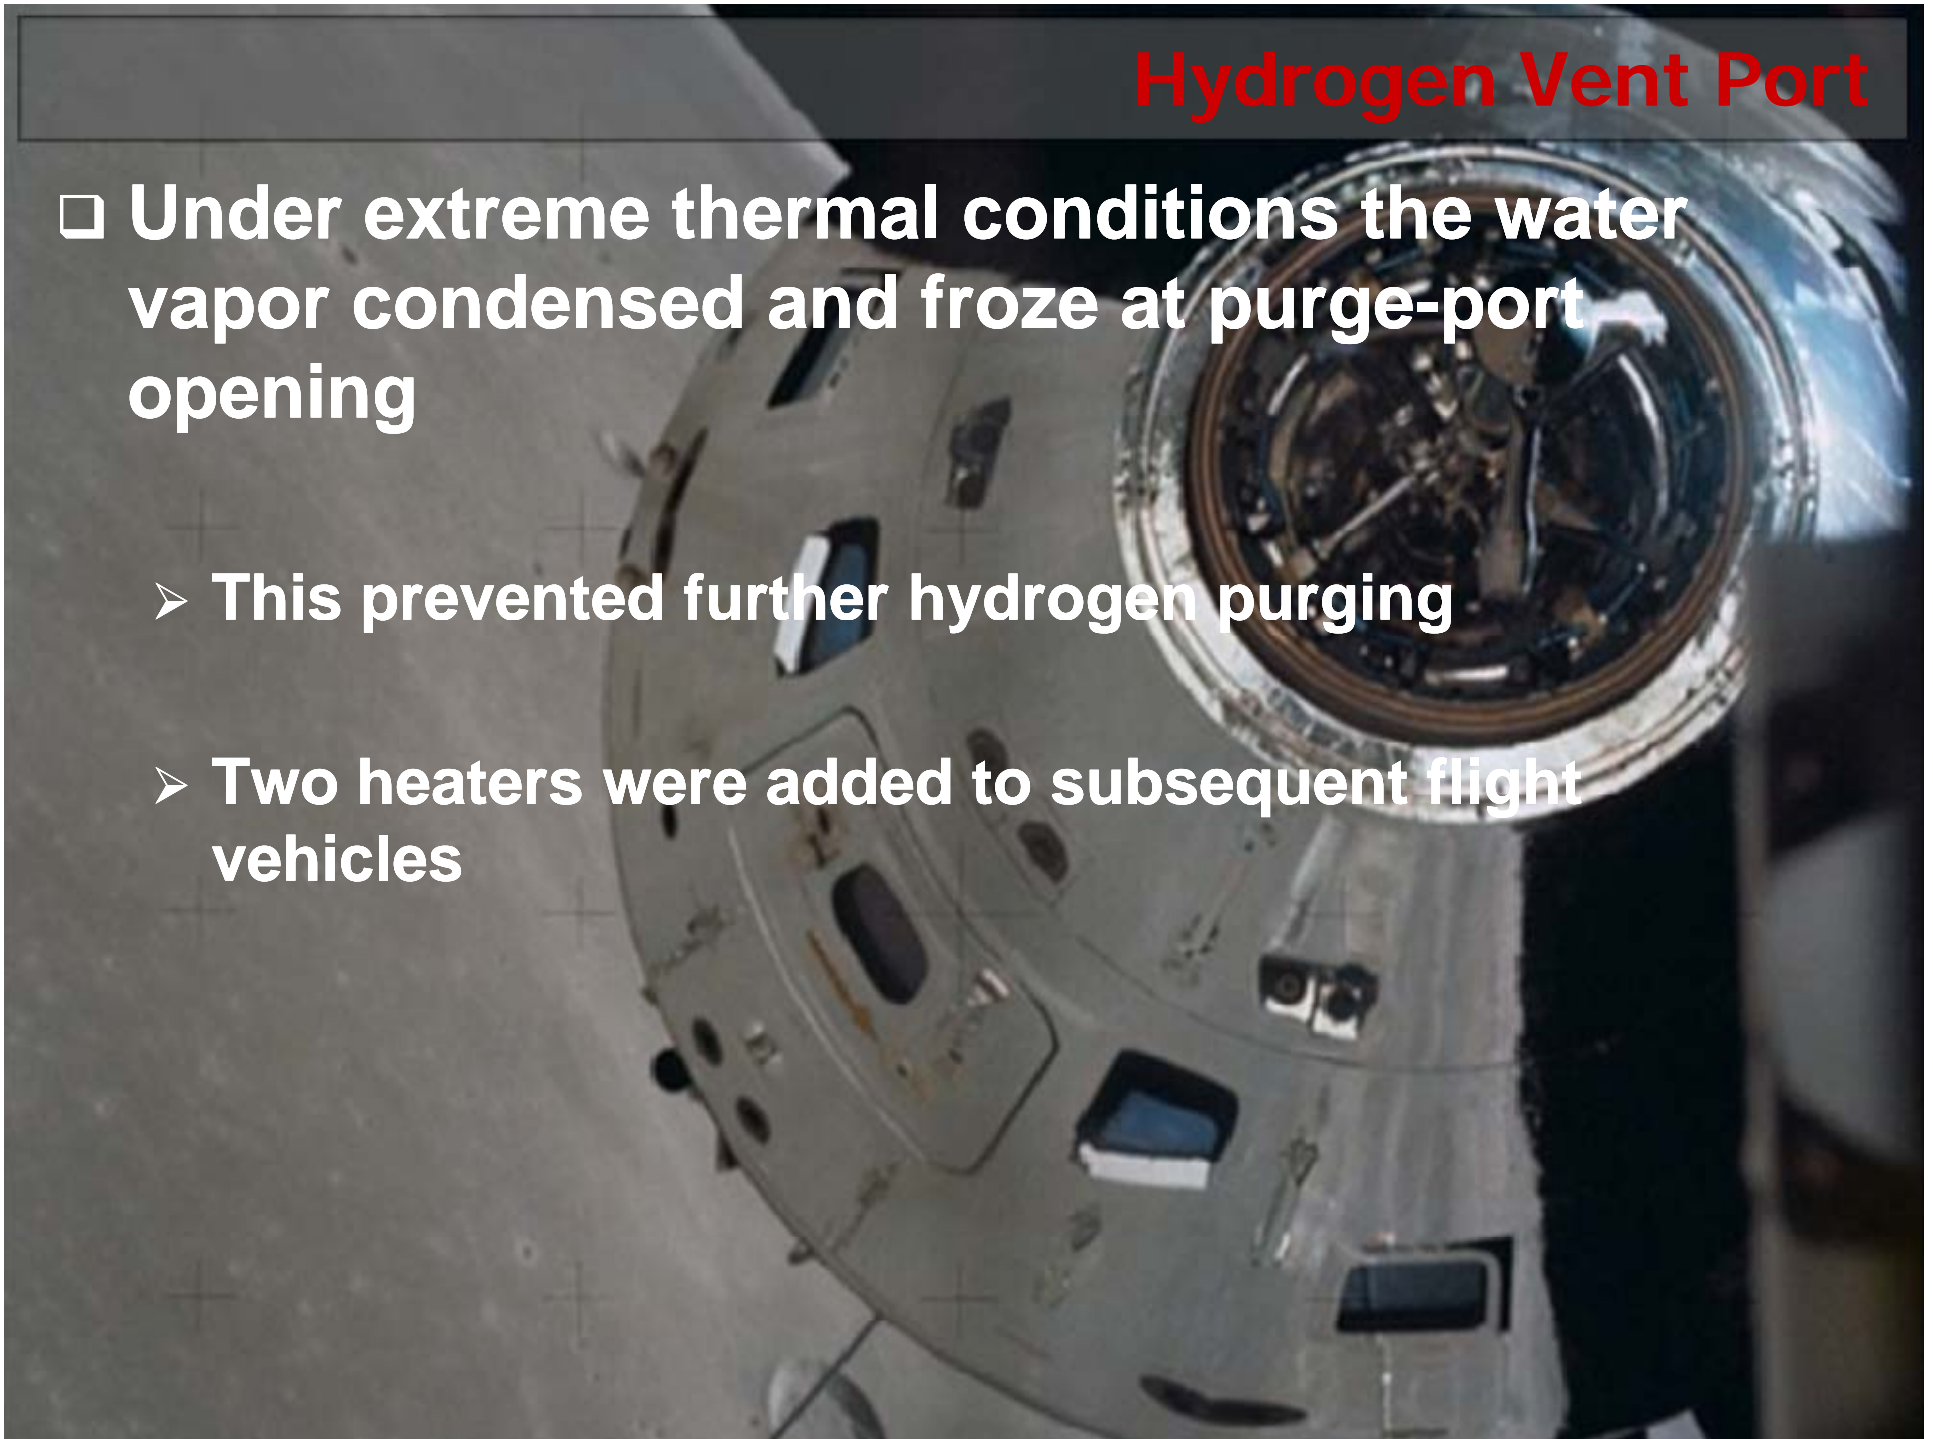
Hydrogen Vent Port

❑ Under extreme thermal conditions the water vapor condensed and froze at purge-port opening

➤ This prevented further hydrogen purging

➤ Two heaters were added to subsequent flight vehicles
